Braille House

Making Tourism Accessible for Visitors who are Blind or have Low Vision

Examples of Unsupportive Design Elements

For those Who Are Blind or Have Low Vision

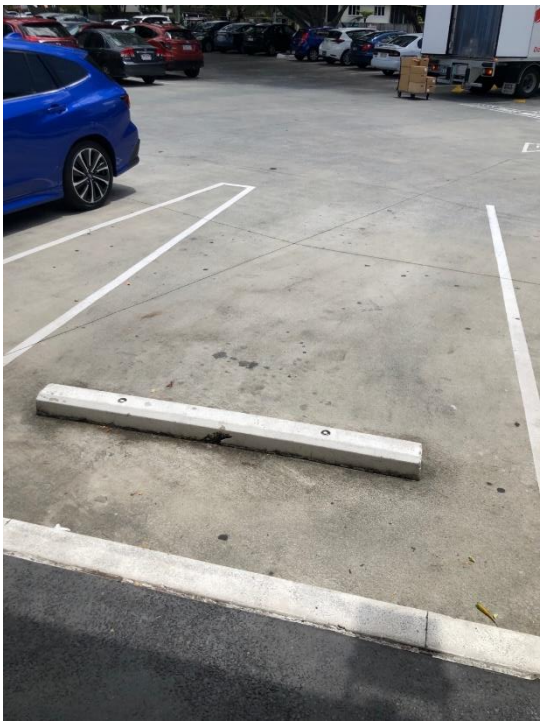
No contrast between concrete wheel stop or curb, and the carpark surface.

No colour-contrast between post and floor surface.

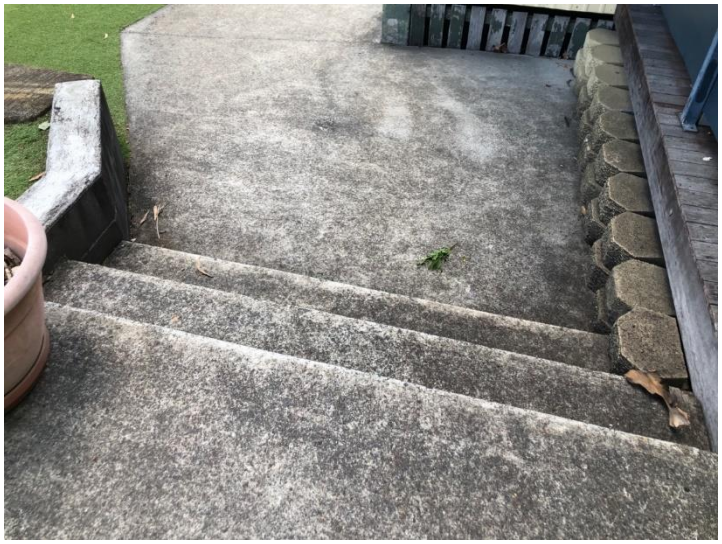
Outdoor stairs without high contrast nosings, or TGSIs

An example of a poor queuing system that projects into the space's main path of travel. However, the system illustrates good colour contrast to the surrounding floor surface.

Signage is on the door, and the door is open. No braille, and the tactile symbol is unrecognisable

Unsupportive lift signage

Supportive raised QR code for pub menu lacks tactile QR code indicator

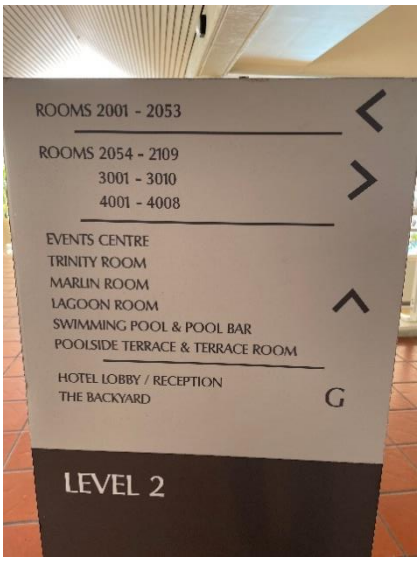
Directional signage without Braille/large print

Ramp without even step / no hi-vis marking

Driveway step without hi-vis marking

Guest room door without Braille identification

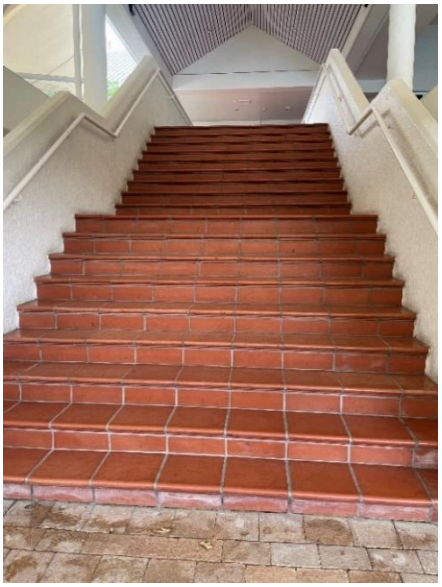
Staircase without hi-vis step markings

Menu lacks accessibility

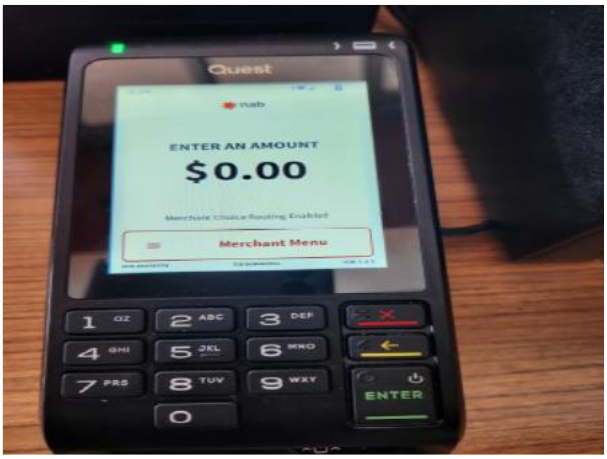
EFTPOS not / possibly not friendly for a sight impaired user

Entrance – no braille signage,
no station for assistance

Bar – requires better signage

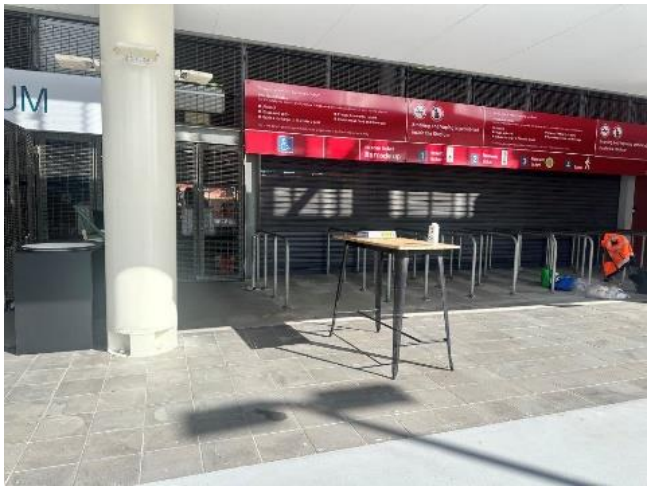
No Braille or tactile signage. No colour contrast between pole and surrounds. Table is in walkway, although this is very temporary. NB Image not taken on an event day.

No Braille or tactile directional signage, although what is provided is shows good colour contrast.

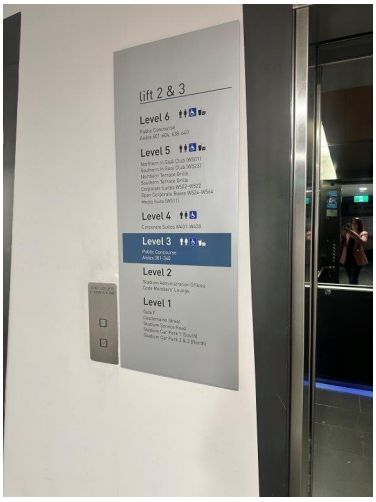
Braille signage outside lift is very extensive, however due to the amount of information and the formatting of the sign, is not height friendly for hands to read Braille.

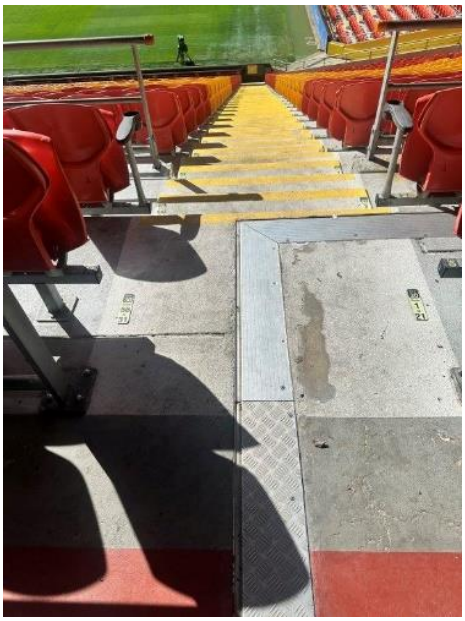
Stairs to seats have no TGSIs.

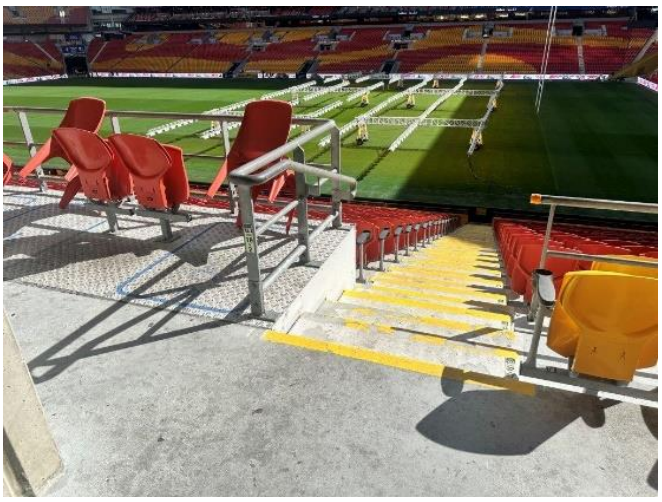
Stairs to seats would benefit from a repaint of the colour contrast. No TGSIs.

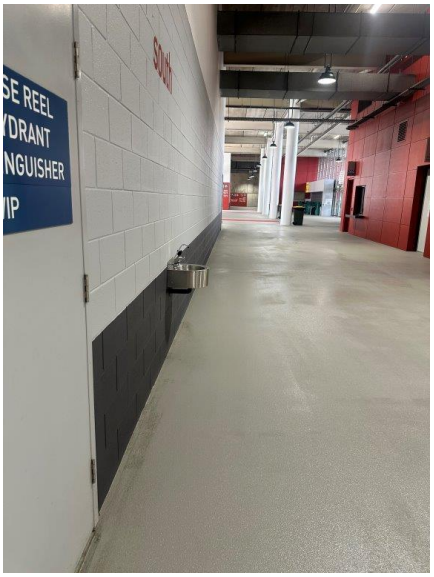
Drinking fountain along walkway juts out from wall, although colour contrast is present. There is no tactile (inc. Braille) signage.

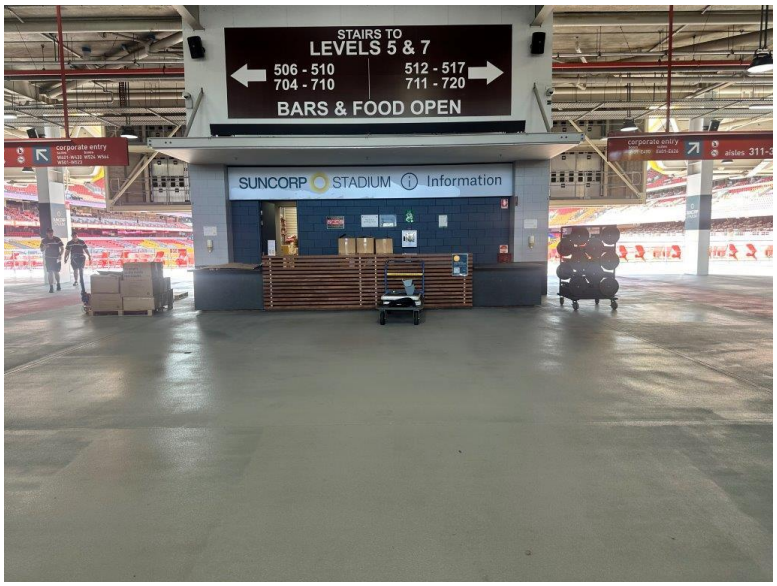
There is no tactile (inc. Braille) signage.
NB Image not taken on an event day.

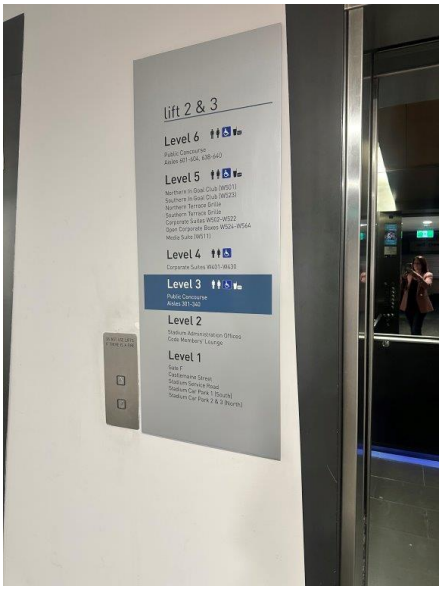
Braille signage outside lift is very extensive, however due to the amount of information and the formatting of the sign, is not height friendly for hands to read Braille.

Unclear where the entry way is

Sandwich boards in middle of walkway

Internal stairs with no tactile markers at top or bottom

No tactile markings to indicate where roadway starts and uneven ground
